CUSHMAN LAKE DAM

NJ 00447

PHASE 1 INSPECTION REPORT
NATIONAL DAM SAFETY PROGRAM

PHASE I INSPECTION REPORT
NATIONAL DAM INSPECTION PROGRAM
NAME OF DAM CUSHMAN LAKE DAM FED. ID# NJ 00447

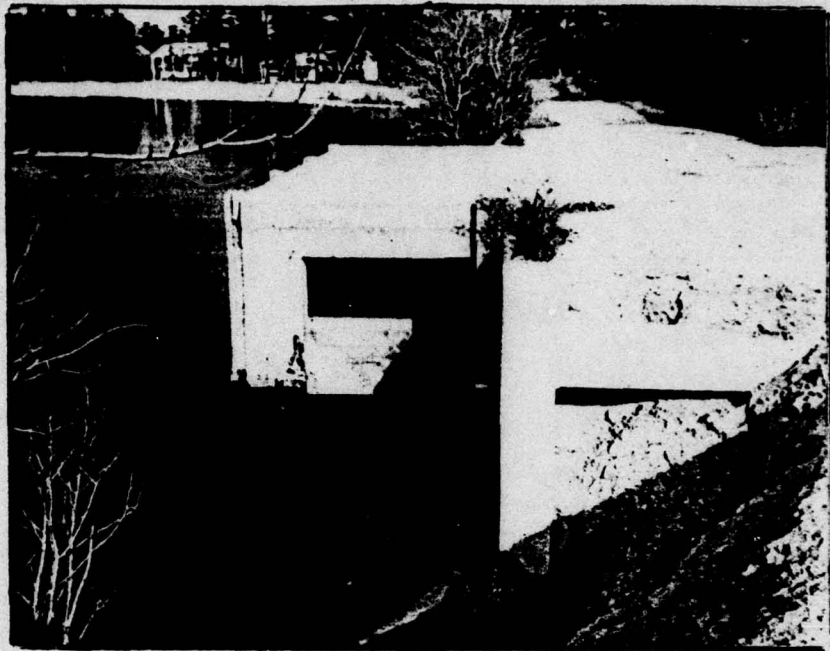
The drop inlet is a 3-sided reinforced concrete frame built monolithically into the culvert. Each of the 5 openings is 6'-0" wide and timber flashboards are positioned on vertical timber runners on the upstream face. The timber is in poor condition and the stoplogs appear to be wedged tightly into position. The concrete edges along the crest is badly chipped and spalled and there are no lifting devices for removal of the stoplogs.

Intake structure

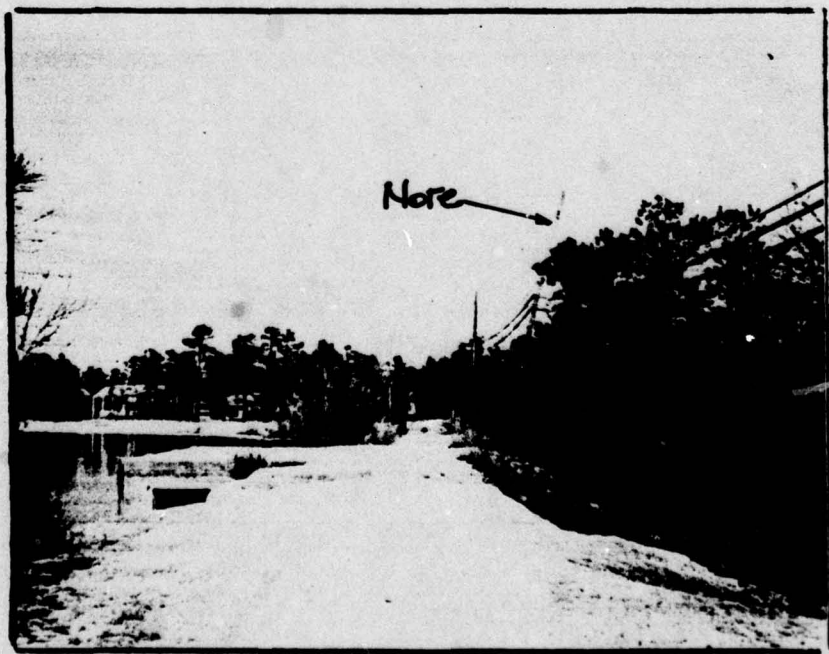
The upper zones of the dam embankment were found to be in a poor condition reflecting its age and apparent lack of maintenance. The crest has a considerable variation in width and elevation and all vestiges of its geometric design dimensions are obliterated. The lake level appears to be quite constant during most periods as the banks are fairly well stabilized and show only minor evidence of sloughing at the waterline. However, the upper zones of the dam foreslopes are badly eroded and undercut in many areas. The backslopes are partially grassed over and contain several large trees and secondary growth. There is evidence of considerable surface run-off and erosion in numerous locations below the dam crest which have incised rather deep erosion gullies, especially at the corners of the spillway wing-walls and an extensive zone north of the spillway. The steeper upstream embankment slopes are very irregular and it appears the lake has silted up considerably against the upstream face. The backslopes show evidence of numerous wet areas at the lower elevations, but most of this appears to be at the natural swamp elevation downstream and not the result of percolation through the dam embankment. The dam crest is extremely rough and requires additional clay binder in the fill material to stabilize the surface which now is in a loose condition as a result of vehicular traffic. The dam is continually being used as an illegal short-cut

Dam crest

(Note: lean of telephone pole)

The entire crest of the embankment should be immediately scarified, recompact and additional fill added to bring it up to proper line and grade. Additionally, the eroded backslopes should be filled in and protected with a suitable ground cover. On the basis of visual inspection, improvements to the present spillway should consist of repairing the exposed concrete surfaces, including sandblasting and applying epoxy-mortar coatings or dry-gunning. The joints should be cleaned out and recaulked. The keeper planks for the stoplogs should be rehabilitated. The embankment at each side of the downstream spillway wingwalls should be further protected with slope paving along the face of each wall. Other remedial measures to be taken under advisement very soon include:

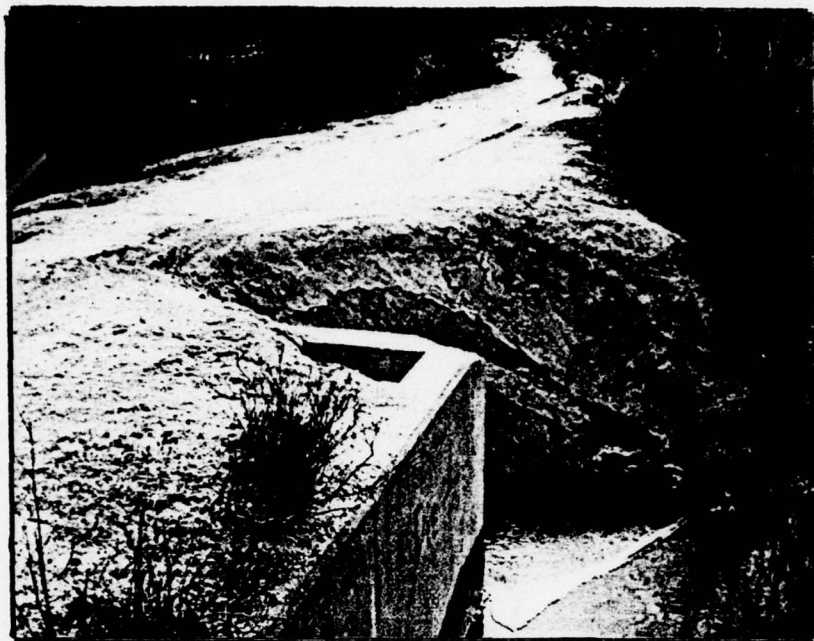
exit from the residential neighborhood to the south. Cars and trail bikes have done extensive damage to the embankment at the south wall of the spillway where the crest is now only 3 to 4 feet wide and in imminent danger of breaching, especially if the illegal vehicular traffic continues.

Severe erosion and sloughing right of spillway

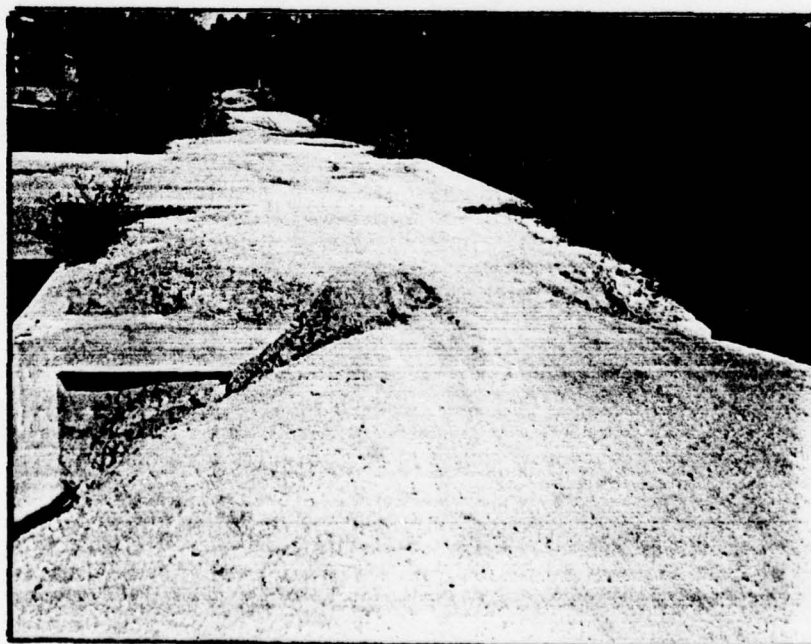
View North along dam crest

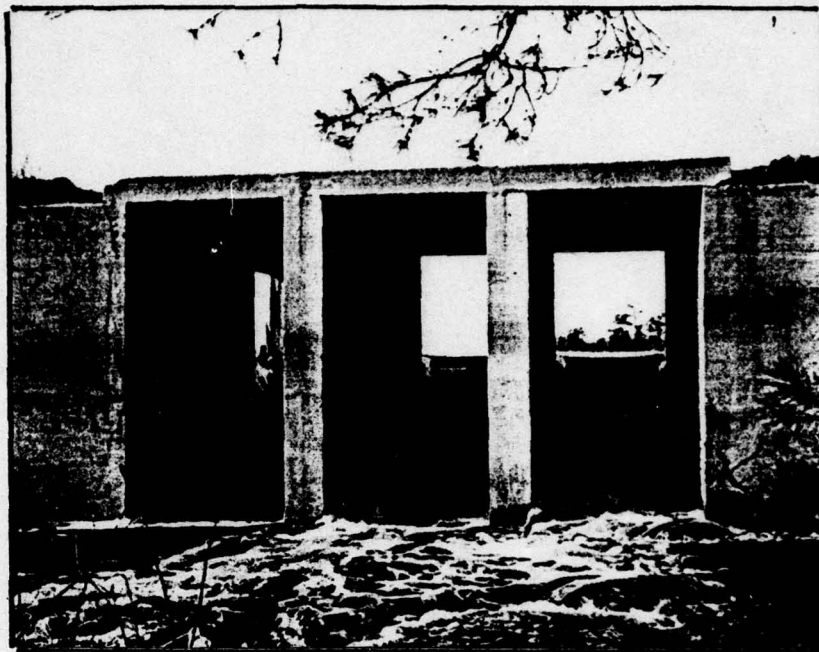
The three-celled reinforced concrete culvert is in moderately good structural condition. Each opening of the culvert has a width of 6'-0" and a clear headroom of 16'-0". The wingwalls and transverse tiebeams display numerous cracked and spalled areas but the structurally important zones are in an integral condition. Its configuration is a modification of the Soil Conservation Service type of design prevalent during the period of construction and is extremely stable and structurally conservative. However, the downstream wingwalls which parallel the axis of the dam are too short to provide adequate sloped embankment returns into the channel. The concrete invert slab is founded on timber piling as are the main footings of the culvert walls and wings. Due to the depth of flow, the condition of the invert slab, could not be observed (at a subsequent inspection trip on 23 February 1979, this invert was still

submerged). Several visible areas of the vertical walls are badly chipped and spalled and need patching. The embankment fill behind each end of the wingwalls is seriously eroded to a depth of 4 to 5 feet. As previously stated, there is an apparent lack of binder in most of the embankment fill, especially near the exposed surfaces.

Outlet structure

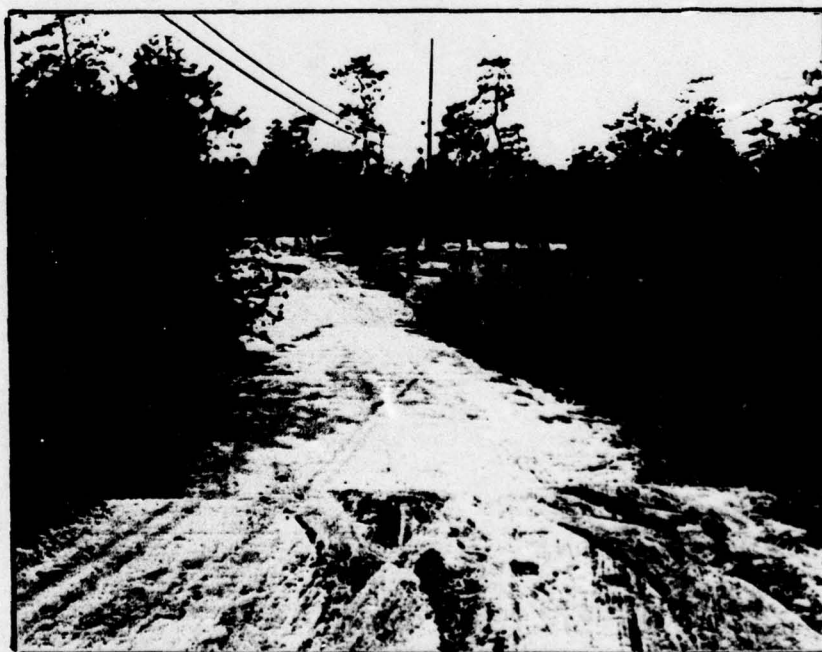
The auxiliary spillways are 90 and 100 feet wide each and are positioned near each abutment. The spillway crest near the right abutment is roughly one foot higher than the left one. Both are paved with asphalt and are in fairly good condition with only minor cracks and ravelling at the edges. A surface drainage ditch has been recently cut immediately to the south of the right auxiliary spillway and is only a few inches above the lake elevation. This apparently was built to drain the tennis court and street immediately to the south of the dam. The effective dam height in this area is very low and there are no true backslopes as the dam blends into the naturally higher surrounding terrain.

Auxillary spillway near right abutment

- removal of the trees on the downstream embankment to lessen the piping potential;
- add riprap stone at the downstream pool immediately below the culvert outlet;
- seal up the cracks in the auxiliary spillways and repair undercut and ravelled edges;
- install timber posts at each abutment across the dam axis to prohibit vehicular traffic.

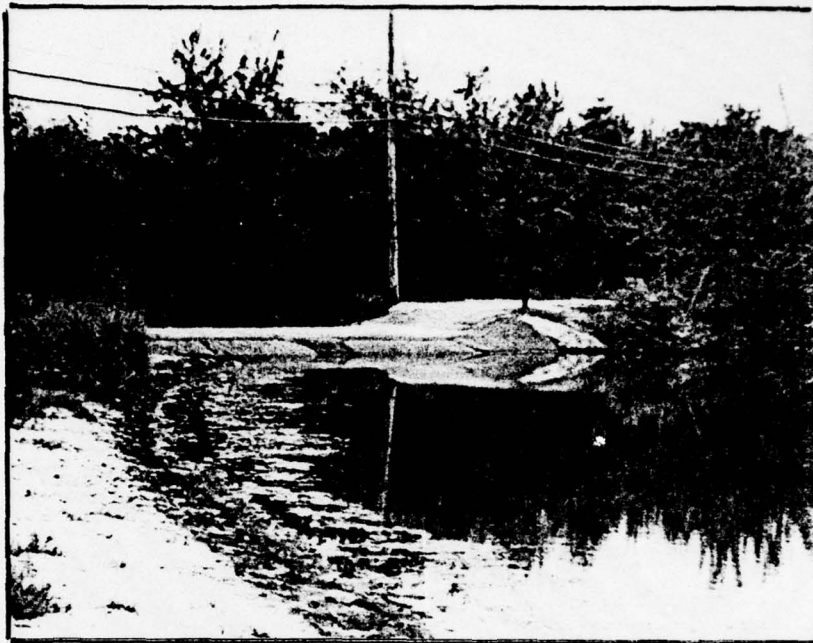
Auxiliary spillway near right abutment

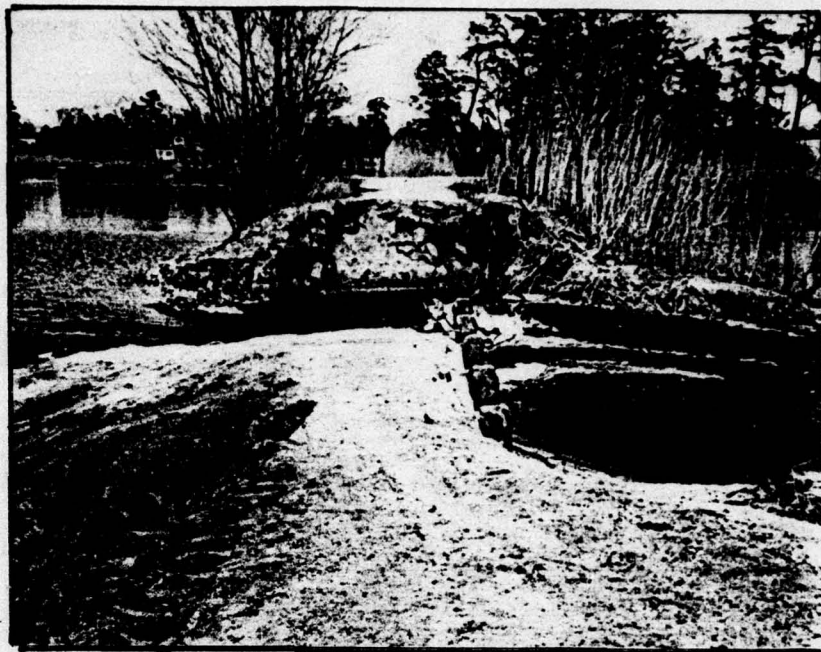
Cushman Lake extends 3,650 feet up to another earth dam where a boat landing is located. This unnamed dam normally impounds Braddock, Cains Mill and Hospitality Lakes but was breached last July (see appended photograph). Therefore, at the present time, the study dam is impounding an additional 46 acres of lake area. It is unknown whether or not repairs are contemplated for the damaged structure. As can be seen in Section 5, the condition of this dam has negligible effect on the study dam. The banks of the connecting lakes are very flat and the surrounding residential areas are only a few feet above the normal lake pool.

Upstream dam failure
